HYDRAULIC MODEL STUDIES OF DEER CREEK
DAM SPILLWAY AND OUTLET WORKS
AND A REPORT ON THE OPERATION OF THE
PROTOTYPE TUBE VALVES AND STILLING BASIN
PROVO PROJECT, UTAH

Hydraulic Laboratory Report No. Hyd.-215

NOVEMBER 21, 1946

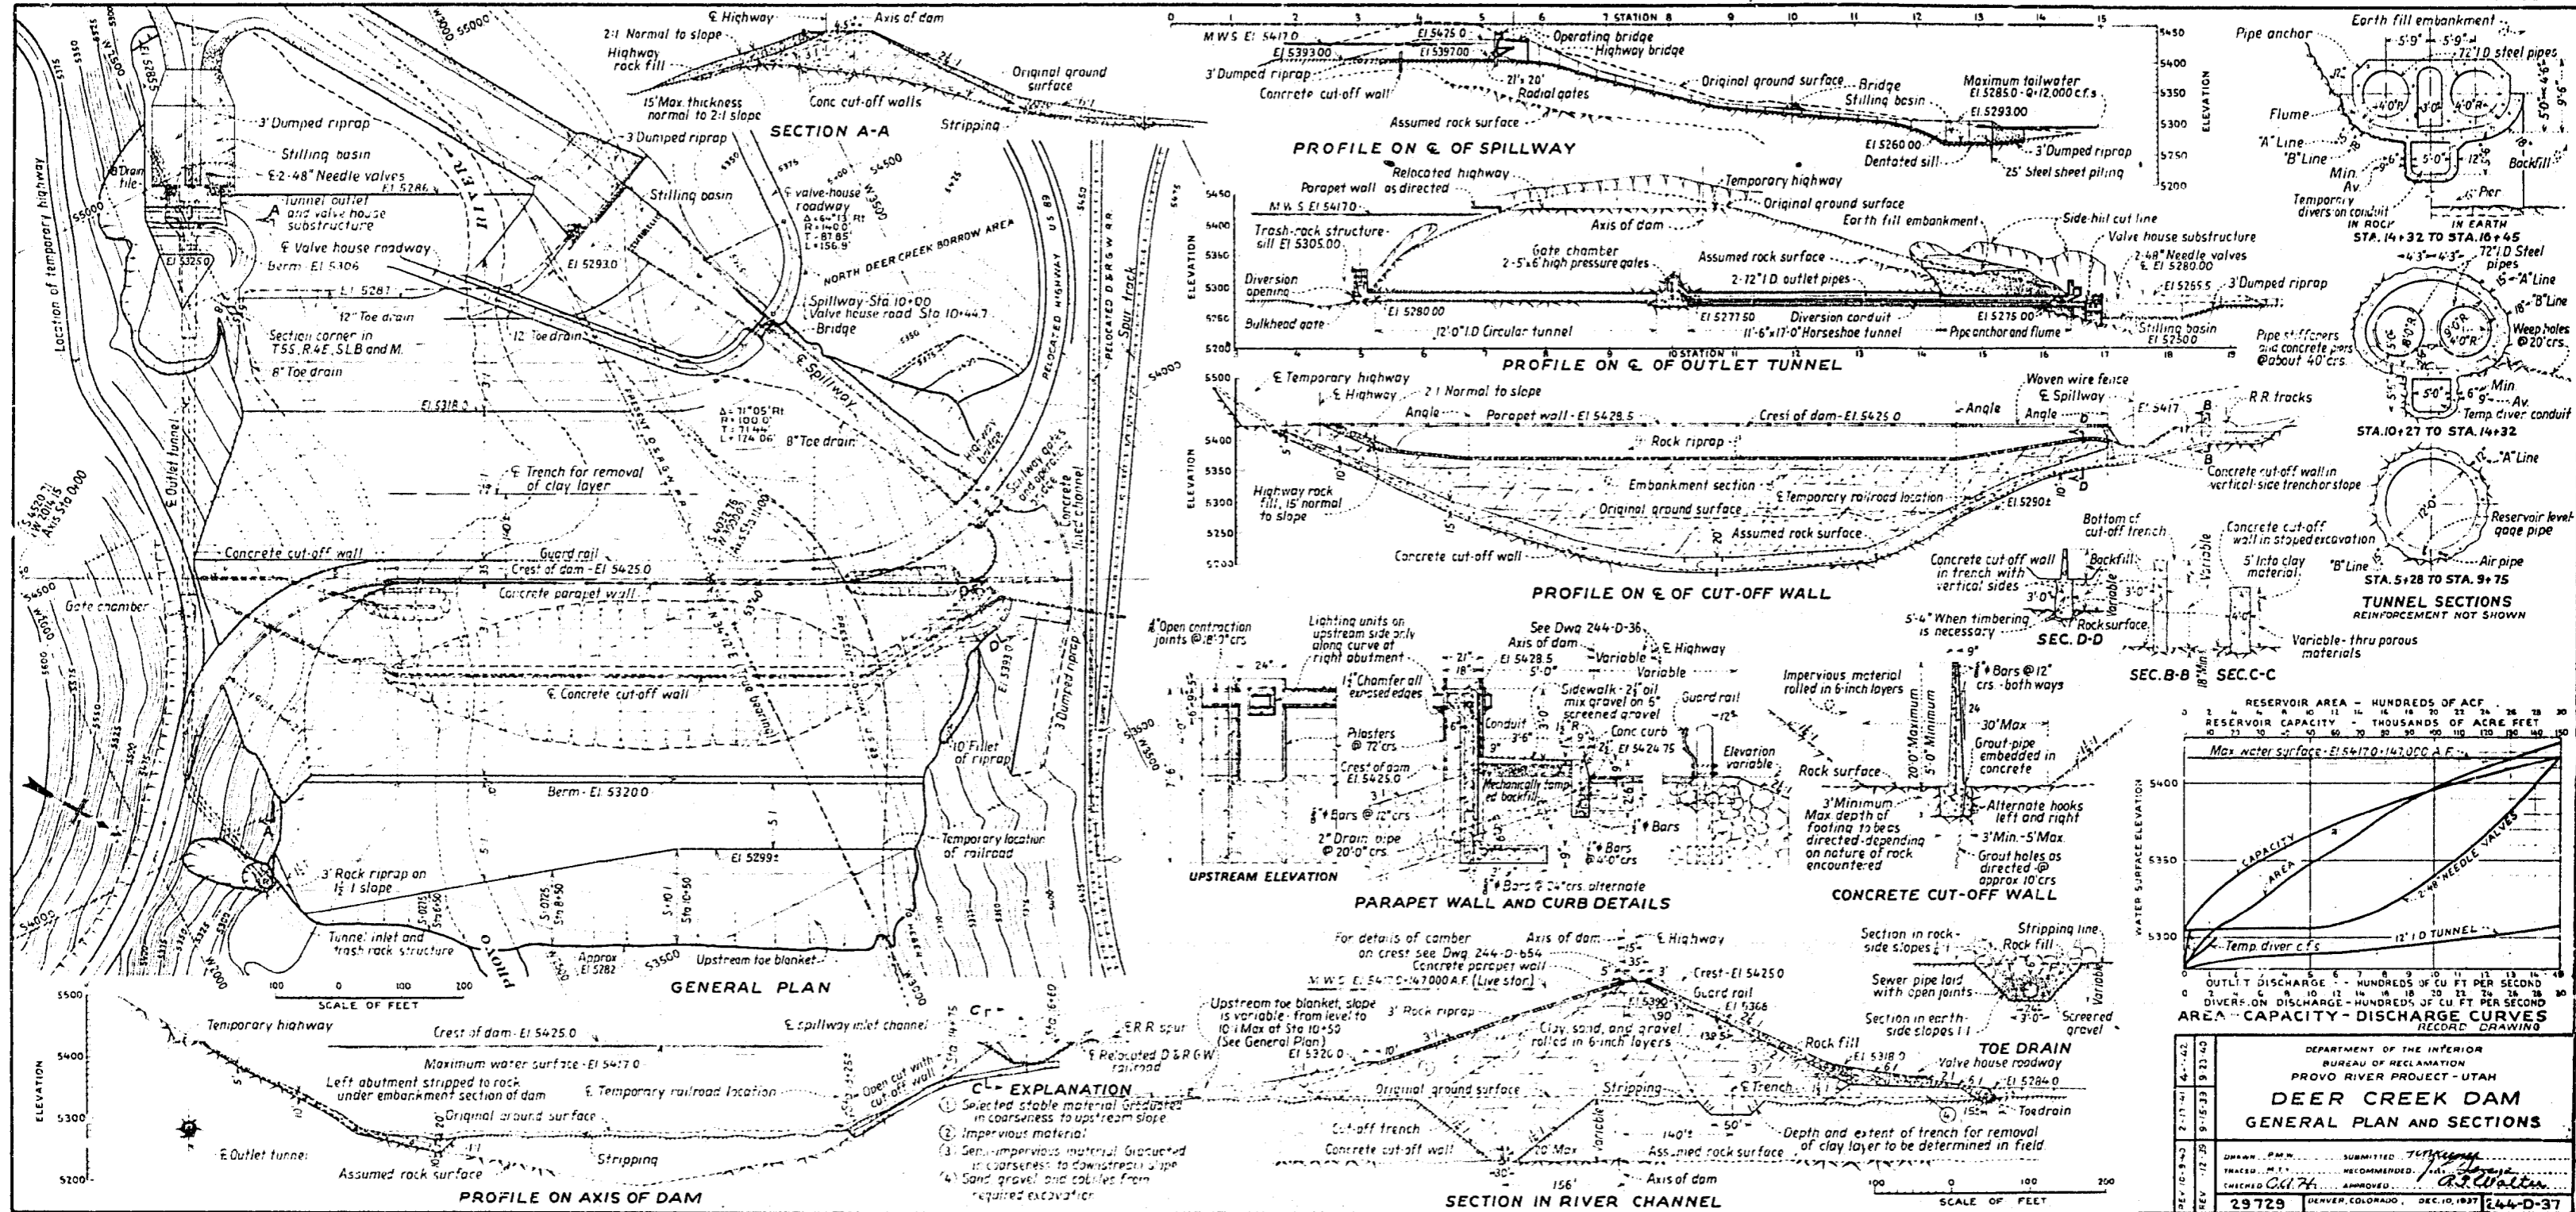
FIGURE 2

DEPARTMENT OF THE INTERIOR
BUREAU OF RECLAMATION
PROVO RIVER PROJECT - UTAH
DEER CREEK DAM
GENERAL PLAN AND SECTIONS

The spillway at the right abutment of the dam (Figure 2) is a concrete-lined open channel approximately 953 feet long, designed to pass a maximum discharge of 12,000 second-feet. Flow is controlled by two radial gates 21 feet long by 20 feet high installed at the crest of the spillway.

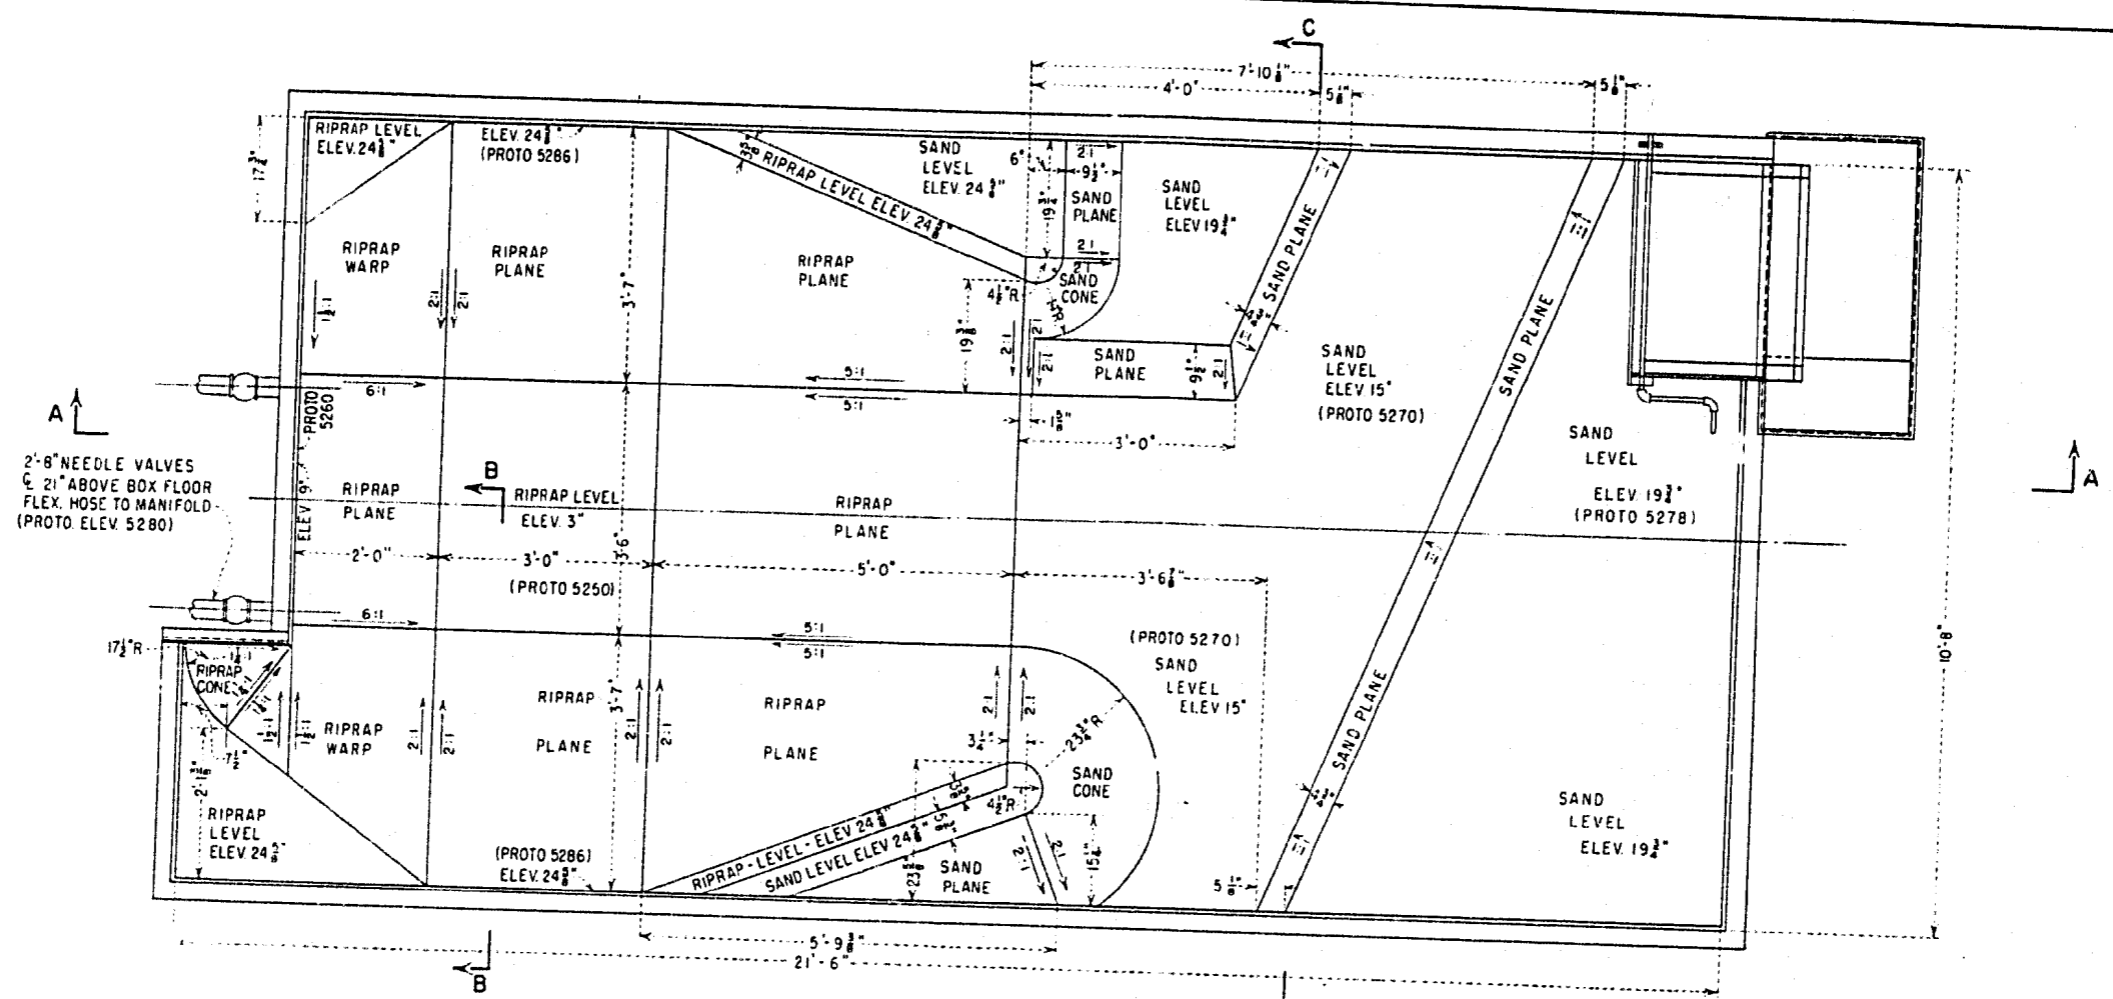
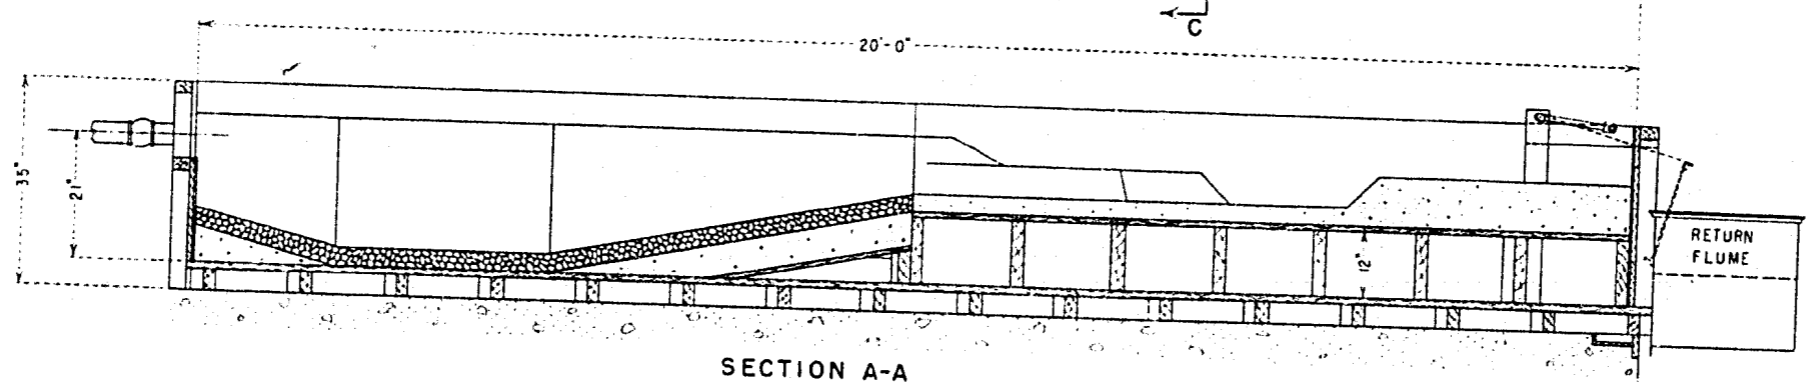
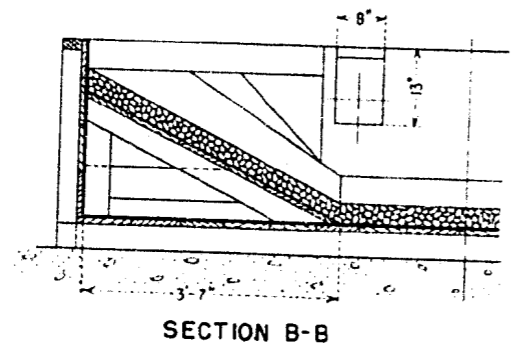
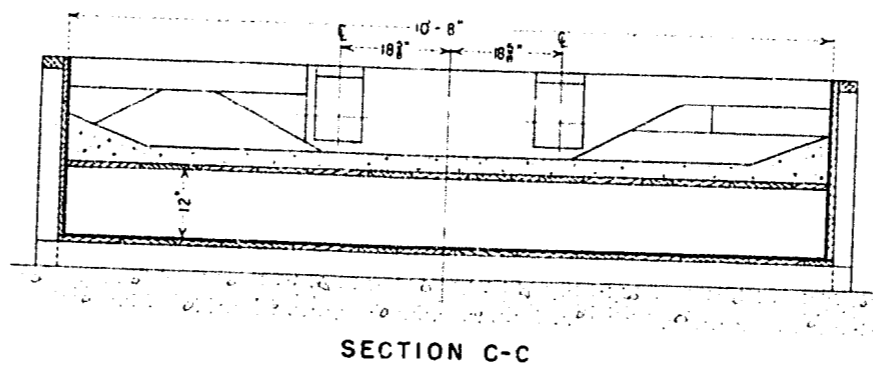
FIGURE 5

ELEVATIONS SHOWN ARE ABOVE THE BOTTOM OF BOX.
 RIPRAP TO BE EVENLY GRADED FROM 1/2" TO 1 1/2"
 GRAVEL AND TO HAVE A VERTICAL THICKNESS OF
 AT LEAST 2"
 (BOX FLOOR-PROTO ELEV. 5245)

The original pool design (Figure 5) was tested with the needle valves set in the following combinations perpendicular to the valve house wall, with a valve convergence of 20 degrees, with each valve depressed 5 degrees and with a valve convergence of 20 degrees together with a depression of 5 degrees. Performance for each valve setting was tested under conditions of single and double valve operation.

A 1:20 model, entirely removed from the spillway model, was constructed of the outlet works. It consisted of a tailbox containing the two 2.8-inch needle valves, the excavated and riprapped areas downstream from the valves, and the necessary water supply piping and measuring devices (Figure 5).

The original design of the stilling-pool (Figure 5) included a dentated step at Station 12+45.00 and a combination Rehbock sill at the downstream end of the stilling-pool. However, it was thought that they might not be necessary for the formation of a satisfactory jump, so the first model test of the pool, DC-18 Figure 11, was made without them.

Effect of valve divergence and depression. The 1-DCO series of tests was run with the original design shown in Figure 5. The valves were placed at an elevation corresponding to elevation 5280 prototype, their axes being perpendicular to the face of the valve house and separated by a distance of 62 feet.

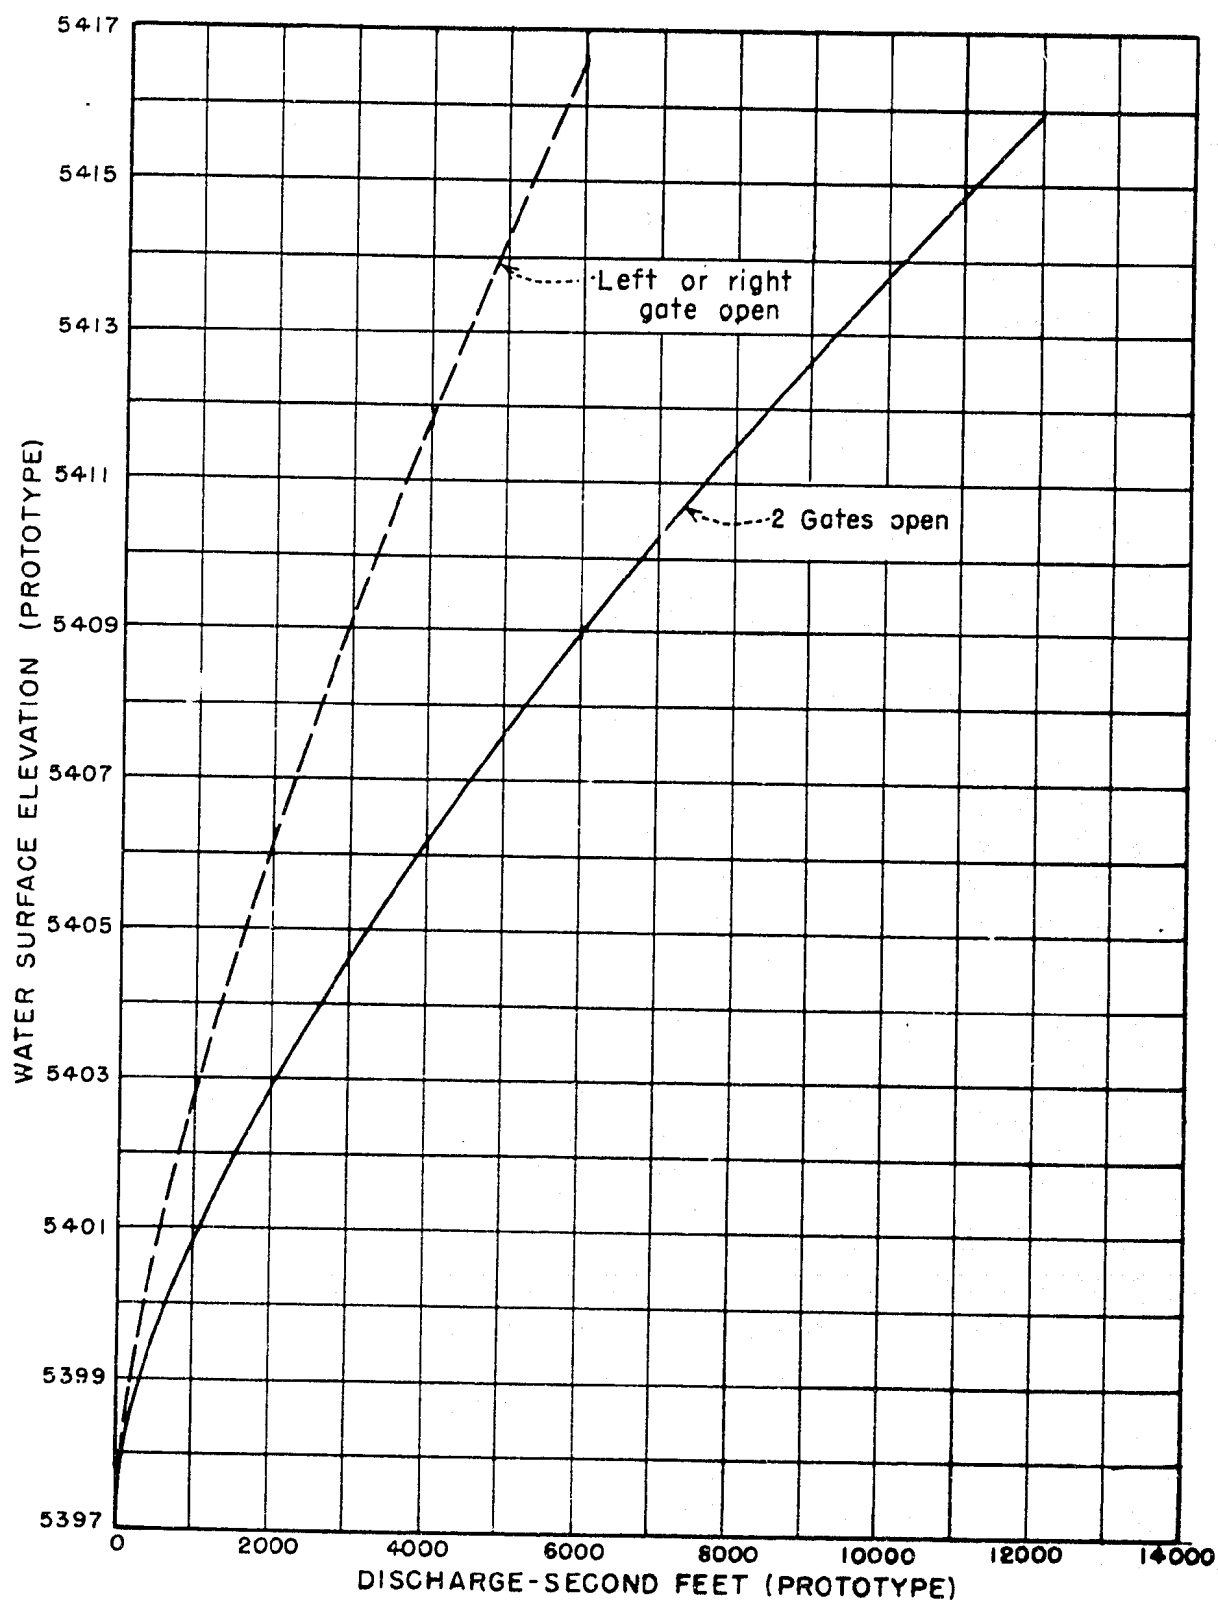
FIGURE 7

DISCHARGE CURVE SPILLWAY CREST
FREE FLOW
1:48 HYDRAULIC MODEL
DEER CREEK DAM

The discharge curves for single and double gate openings obtained from these tests are shown in Figure 7.

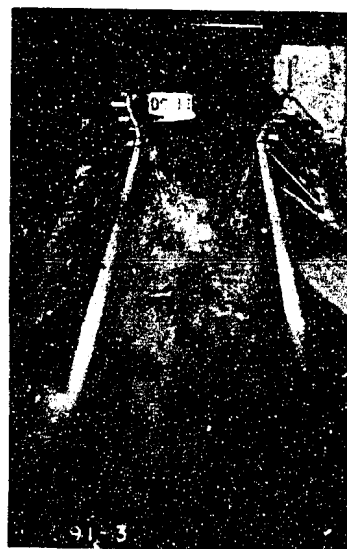
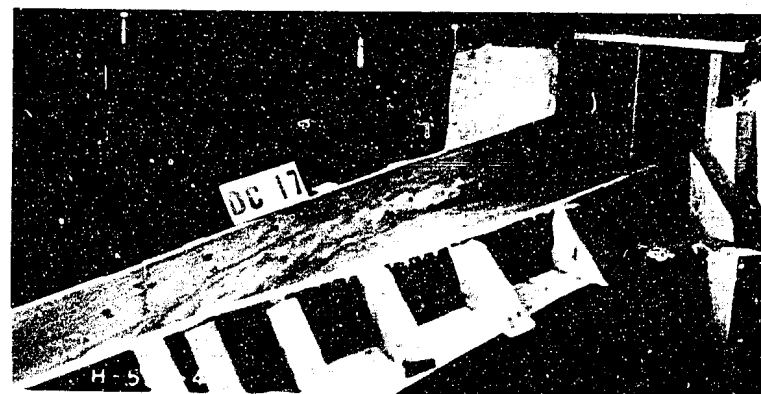
Discharge of 5,300 second-feet, left gate open

DEER CREEK DAM
CHUTE STUDIES
Original Design

The final design (Figure 9) greatly decreased the abruptness of the upper transition and performed satisfactorily at all discharges. Tests at 5,300 second-feet, with the left gate open, also showed an even distribution of the flow entering the stilling-pool.

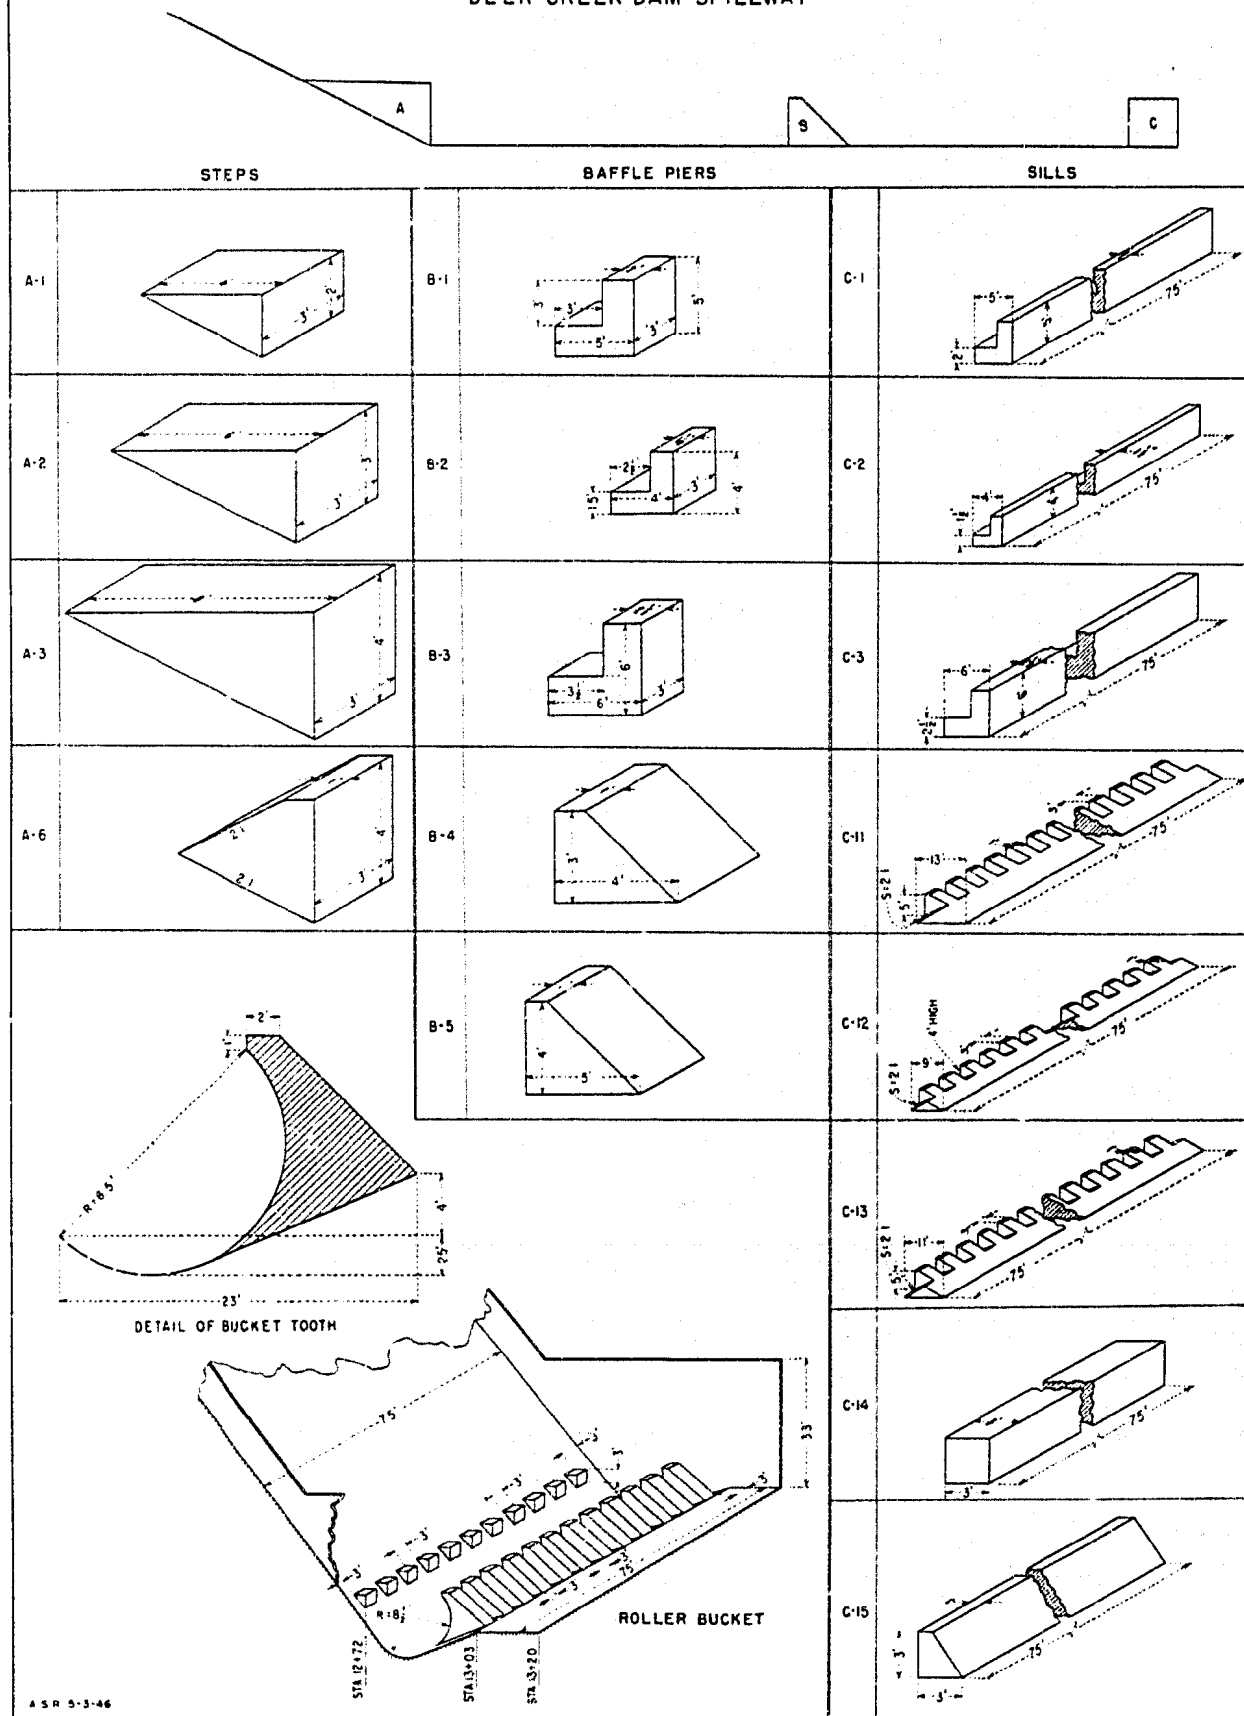
Test DC-18--No Flow Arresters

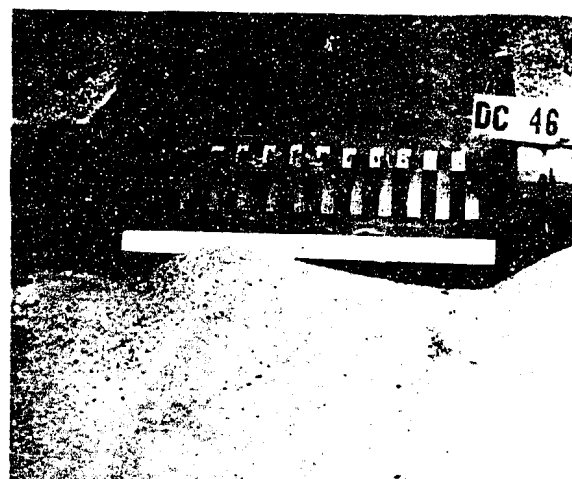
Test DC-19--Step Only

Test DC-29--Step and Sill

Test DC-28--Step, Baffle Piers,
Sill

Test DC-46--Bucket Design

DRY CREEK DAM
SCOUR STUDIES--REPRESENTATIVE TESTS
Erosion After Flow of 12,000 Second-feet for 30 Minutes

Tests with several types of flow arresters in the stilling-pool and without riprap demonstrated the necessity of installing such devices to reduce scour (Figure 11) and to permit a reasonable variation in tailwater without destroying the effectiveness of the jump (Figure 15). The design shown in Figure 14, which made use of 11 Type A-2 dentated steps (Figure 10) 12 B-5 baffle piers at Station 12+95 (Figure 10) and a Type C-5 sill (Figure 14), was recommended for construction in the field. Tests on this scheme indicated a maximum scour of approximately 6 feet, located about 15 feet below the end of the apron (Figure 14), and also showed that a reduction in tailwater elevation of 3 feet below normal at 12,000 second-feet was necessary to cause the jump to sweep out of the pool.

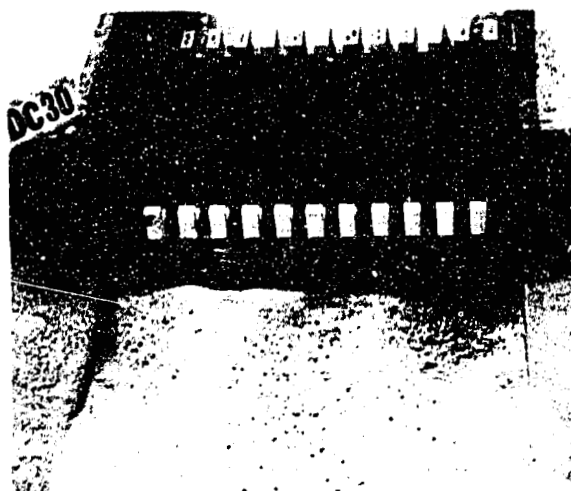
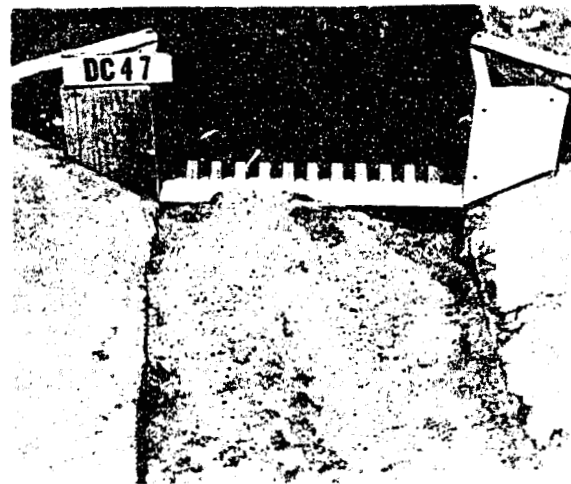
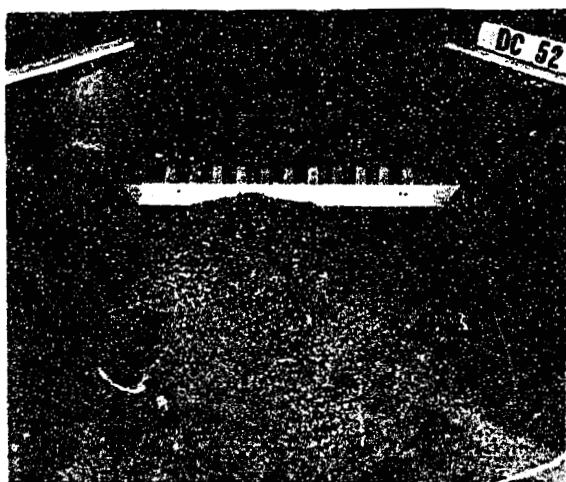
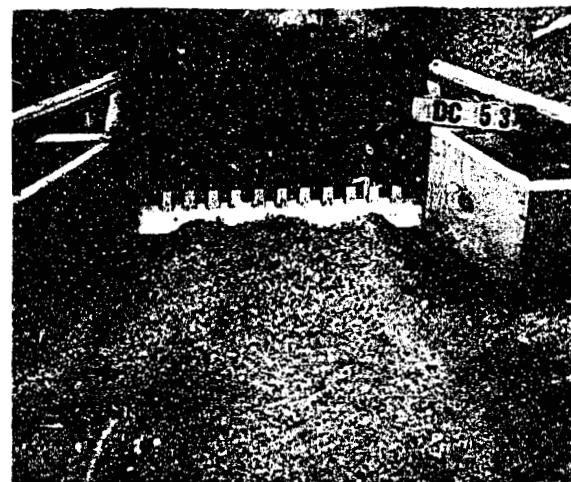
Test DC-32--Step, 2 Rows of Baffle Piers. Sill

Test DC-30--Step, Baffle Piers, No Sill

Test DC-38--Auxiliary Training Wall

Test DC-47--90° Wing Walls

Test DC-52--45° Wing Wall

DC-53--Extended Pool, 45° Wing Walls

DEER CREEK DAM
SCOUR STUDIES--REPRESENTATIVE TESTS
Erosion After Flow of 12,000 Second-feet for 30 Minutes

| Test | Number and type of steps used | Number, type, position of baffle piers used | Type of sill used | Observations |
|---|---|--|---|--|
| DC-48 | 10, A-2 | 10, B-4, Station 13/02 | C-4 | Using 90° wing-wall; much better scour conditions than DC-47. |

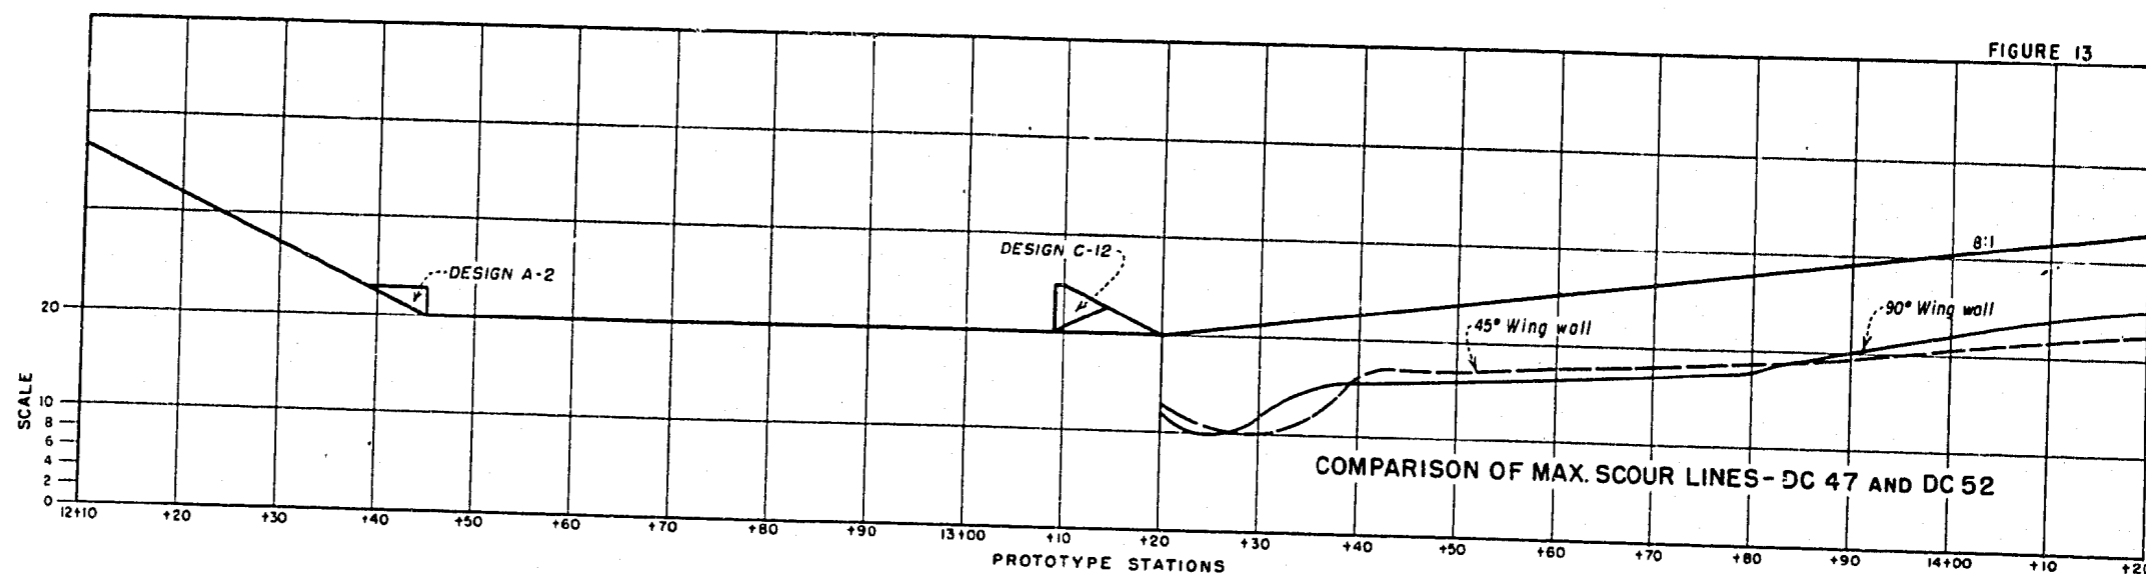
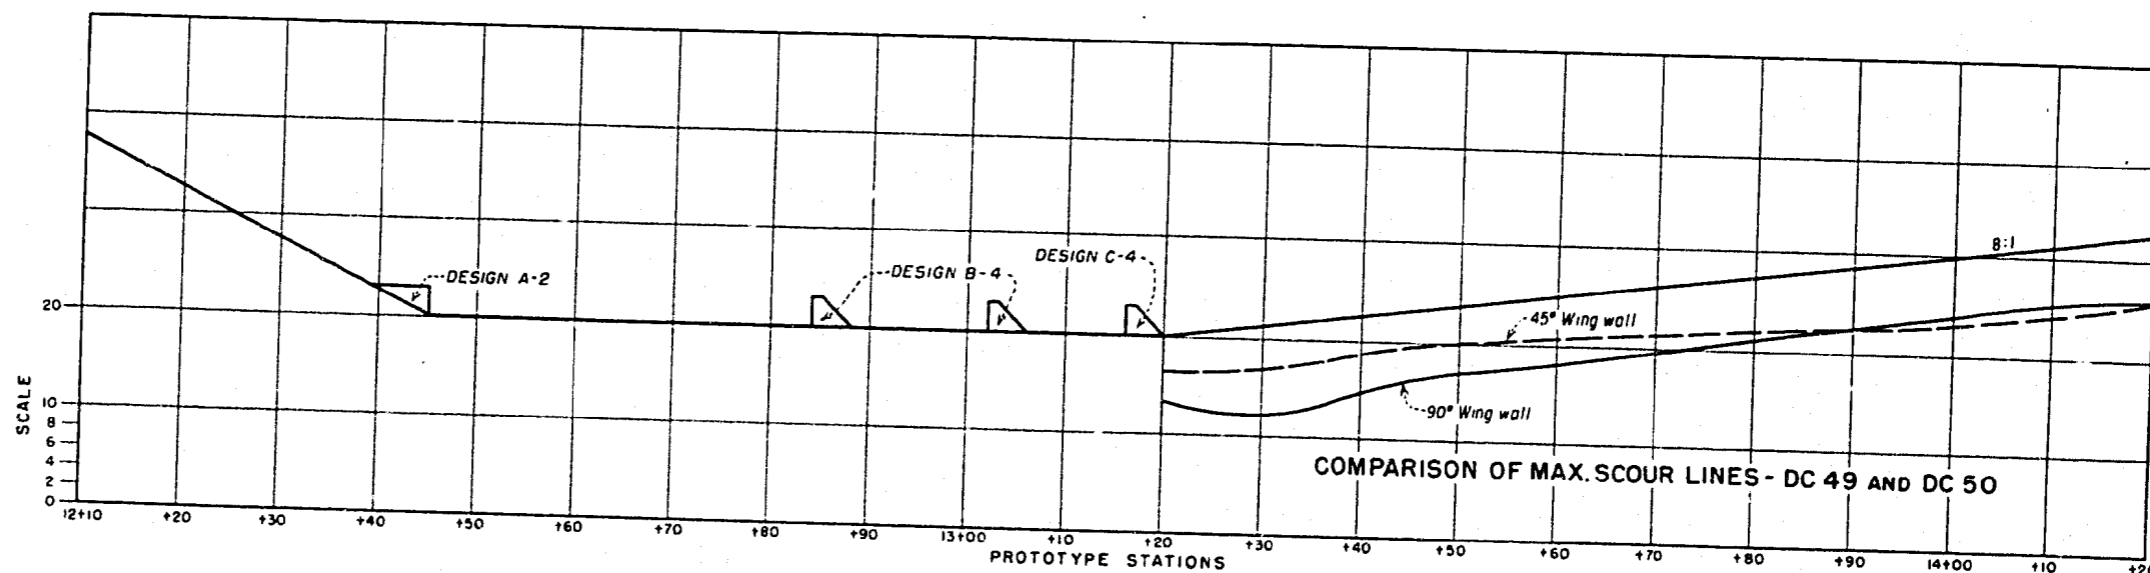
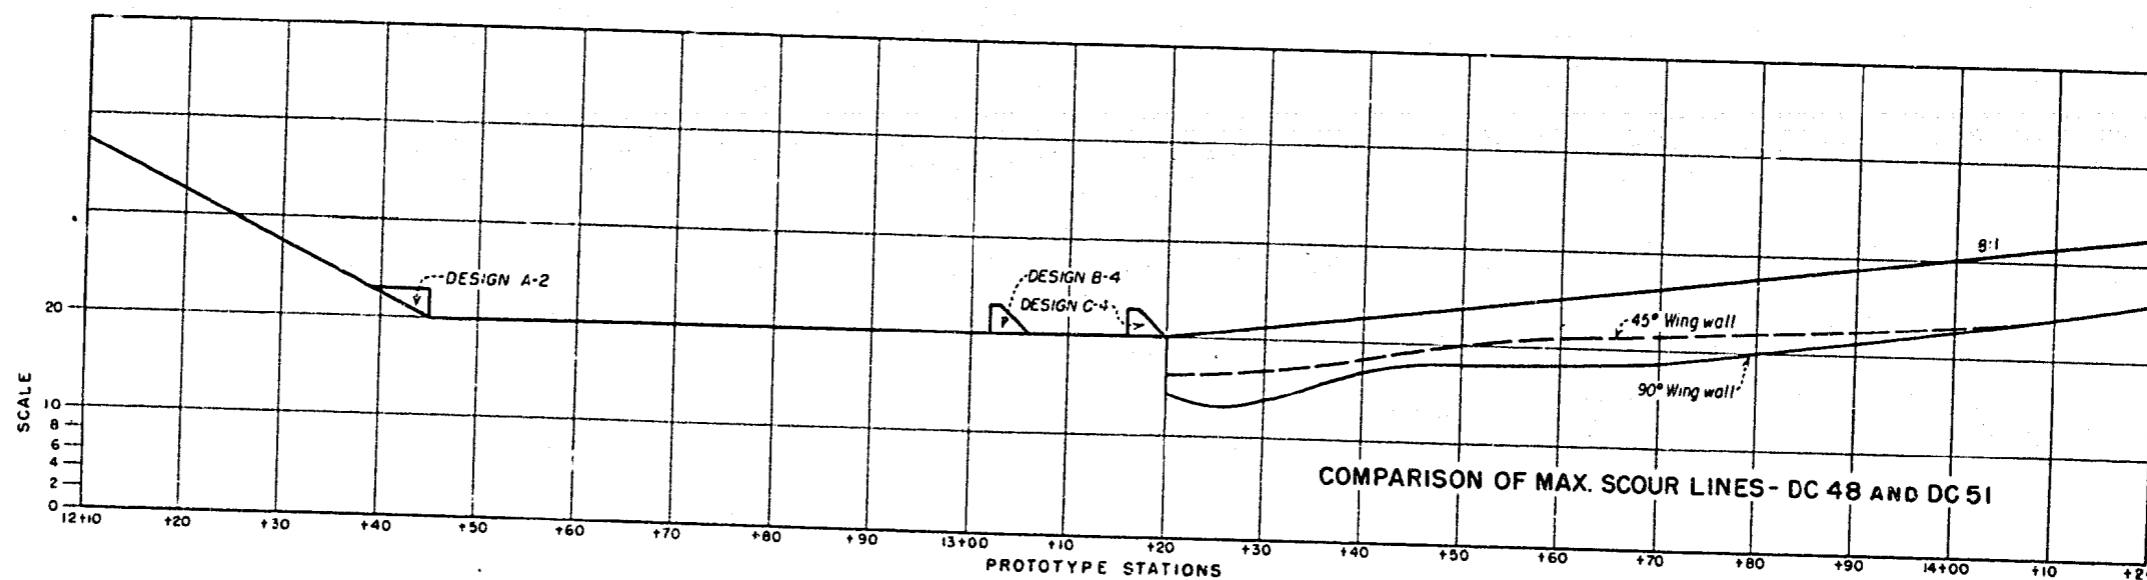
FIGURE 13

COMPARISON OF SCOUR WITH 45° AND 90° WING WALLS

scour below the paved apron. All tests were run without riprap in the area below the stilling-pool. Scour and water-surface profiles were taken for the two final designs, and for several comparable designs involving 90-degree and 45-degree wing-walls (Figures 13 and 14).

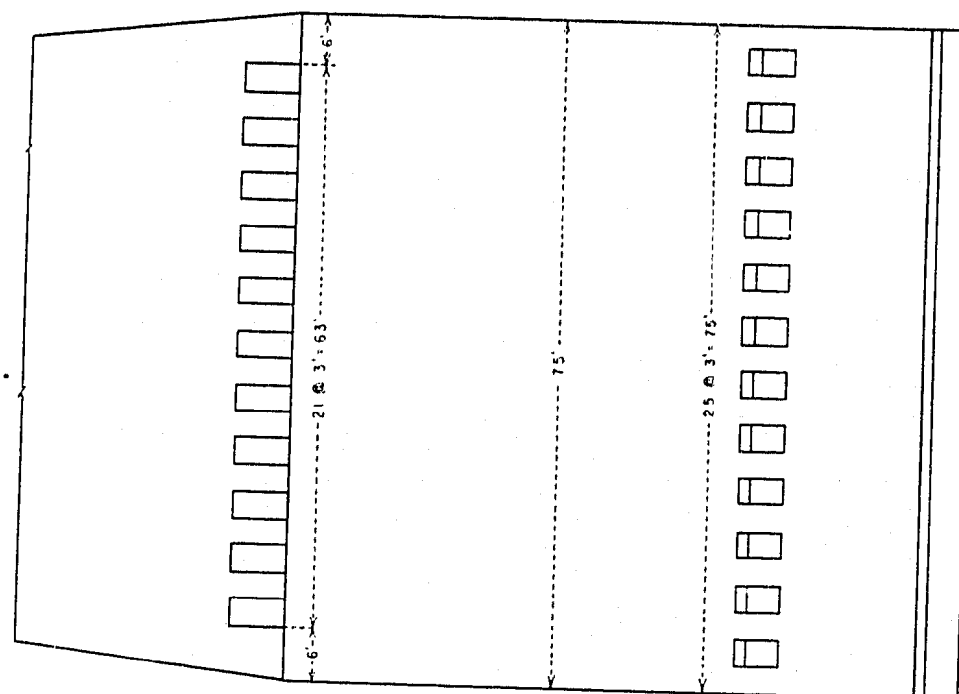
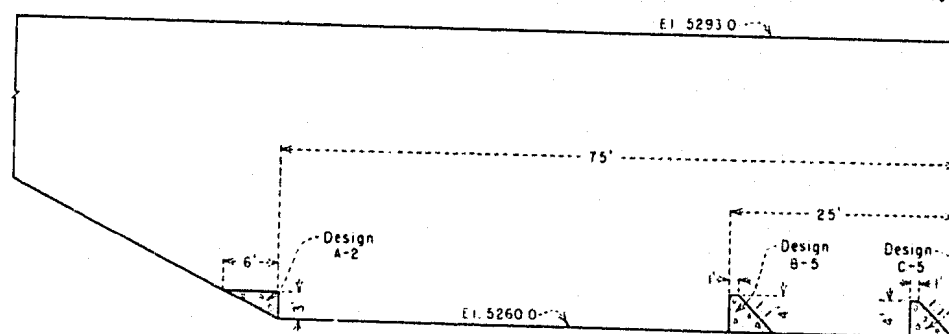
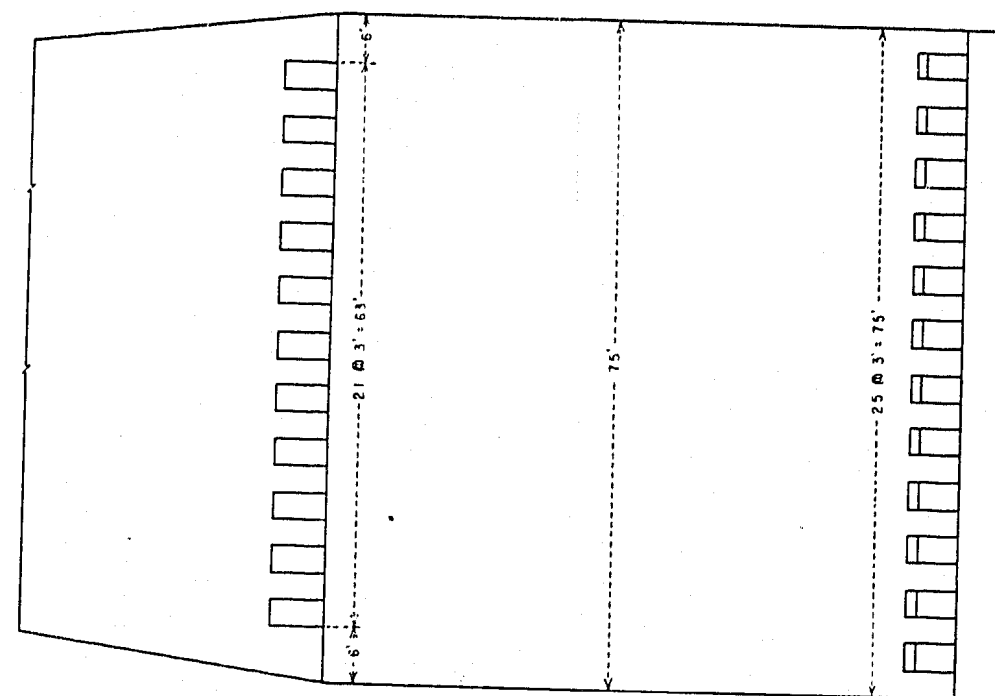
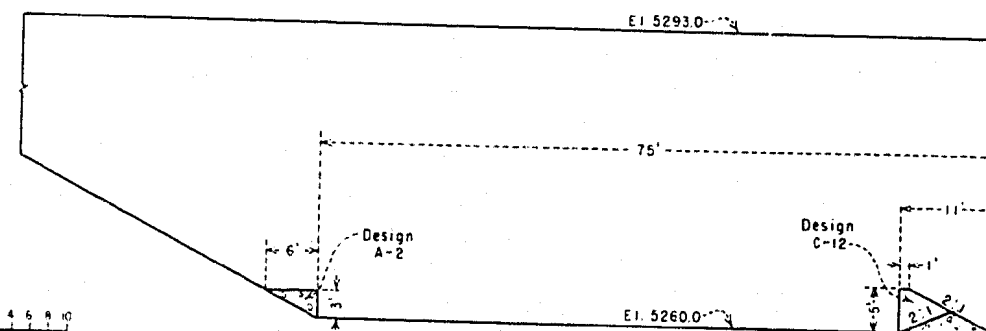
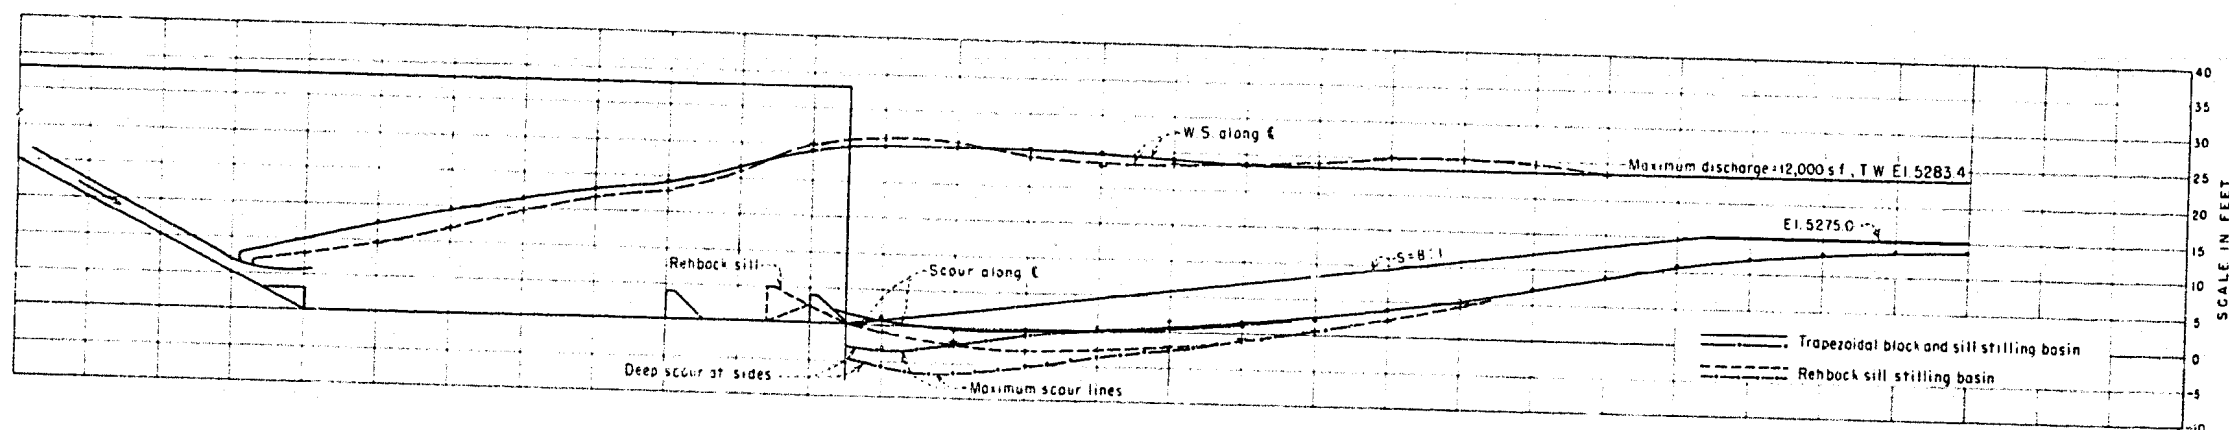
A - RECOMMENDED TRAPEZOIDAL BLOCK AND SILL STILLING BASIN

B - RECOMMENDED REHBOCK SILL STILLING BASIN

COMPARISON OF W. S. PROFILES AND SCOUR FOR BASINS A AND B

WATER SURFACE PROFILES
AND SCOUR LINES
1:48 HYDRAULIC MODEL STUDIES
DEER CREEK SPILLWAY
A-54 5-7-46

It was recommended, therefore, that this combination be adopted for prototype construction. Model tests indicated a maximum scour of approximately 6 feet occurring at Station 13+95 with a maximum depth of erosion at the base of the sill of less than 4 feet. This was much less than that indicated by a comparable test using the Rehbock sill.

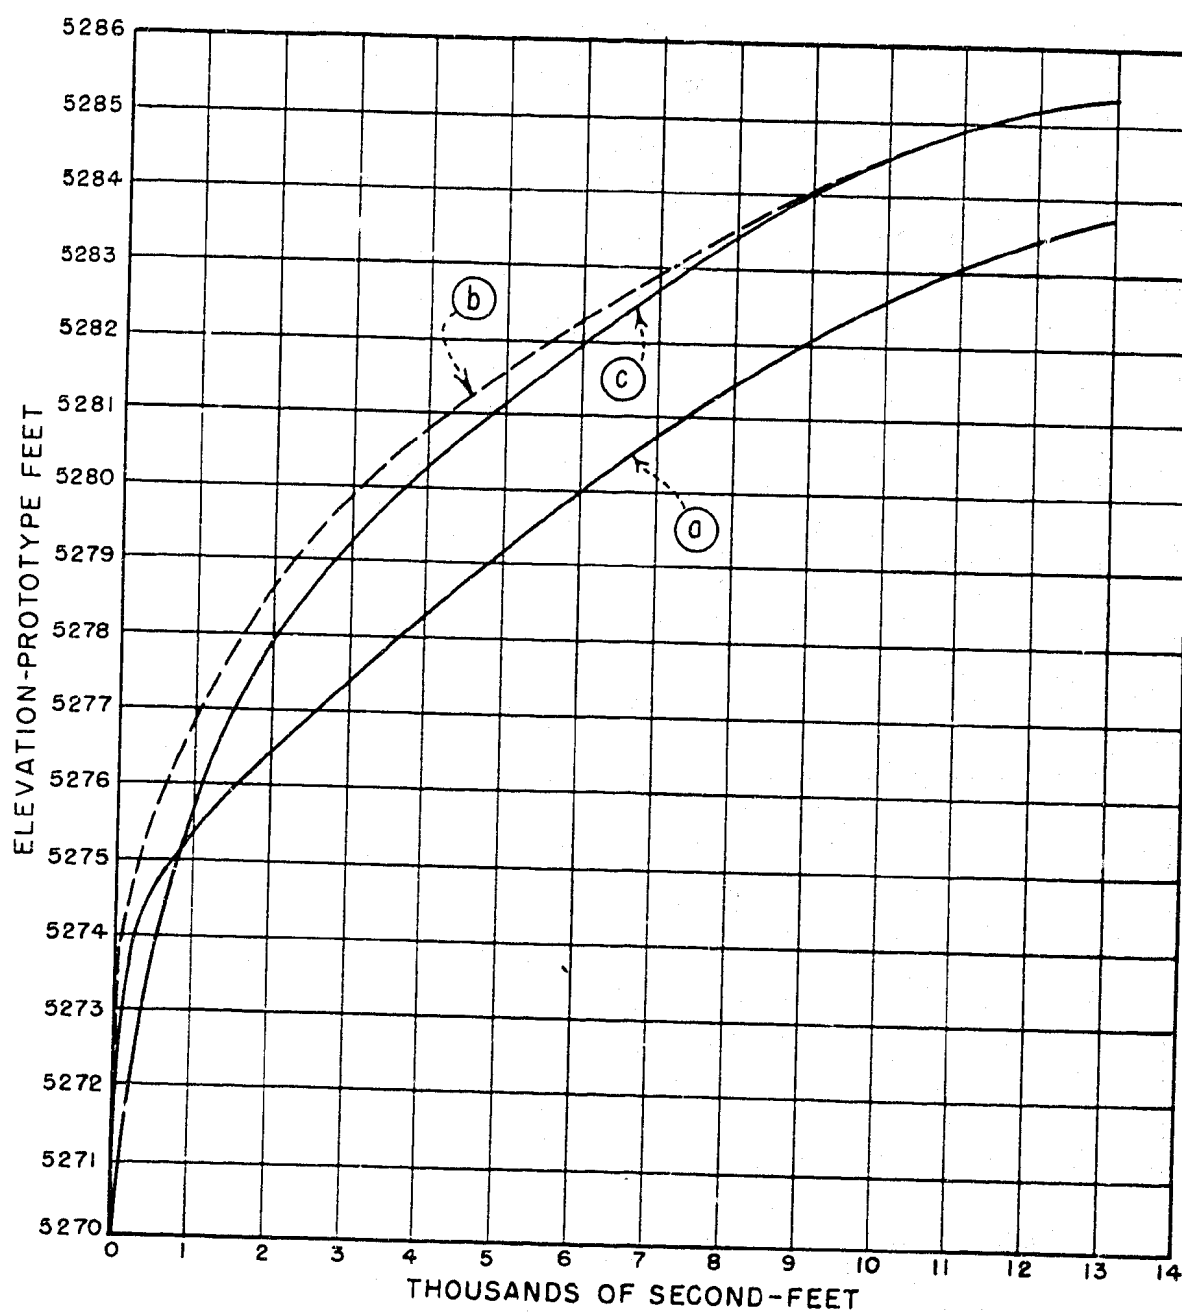
FIGURE 16

- a Stage discharge curve at sta. 15+60 with channel excavation
- b Stage discharge curve at sta. 7+80 without channel excavation
- c Stage discharge curve at sta. 7+80 with channel excavation

COMPARATIVE TAILWATER CURVES
1:48 HYDRAULIC MODEL
DEER CREEK DAM

Considerable difficulty was experienced in determining the proper tailwater elevation for each discharge. During the first series of tests, 1-DCO-1 to 4-DCO-3A, inclusive, Curve A in Figure 16 was used. This was a computed curve for a station approximately 220 feet downstream from the end of the outlet pool, based on the premise that considerable excavating and cleaning of the river channel below the dam was to be done. At the beginning of the 5-DCO series of tests, it was decided that this work would not be done, and Curve C was recommended for use in the remaining tests. The curve was based on a section about 560 feet nearer the dam. This uncertainty was responsible for the variations in tailwater elevations for equal discharges, which may be noted in the description of the tests.
